### Damaged Dräger vaporizer interlock pin: potential for a fatal anaesthetic incident

**Christie N Mato, Maxwell Tobin**, University of Port Harcourt Teaching Hospital, Nigeria

We wish to report the potential for a fatal intraoperative incident related to a damaged Dräger vaporizer interlocking pin.

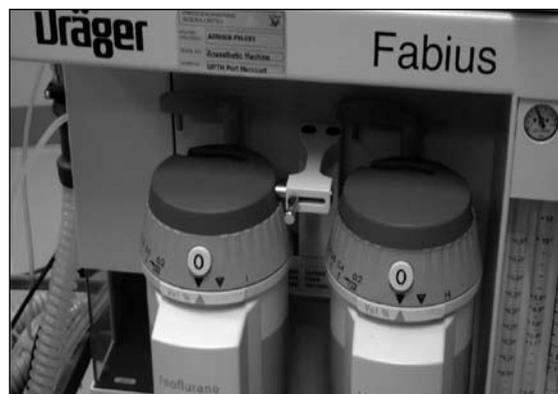
The anaesthetic machines supplied to our hospital have the halothane and isoflurane vaporizers in series with an interlocking bar in between (Figure 1). This interlocking bar prevents the two vaporizers being used at the same time. There are two holes with 'nibs' on the control dial of each vaporizer. The nib in the hole prevents the locking bar from sliding into the hole unless the vaporizer is first turned off. Thus, to change from halothane to isoflurane, the halothane vaporizer must be turned off before the locking bar can slide into the hole and lock it to allow the isoflurane vaporizer control to be turned on for use. If the halothane vaporizer is still in use and the sliding bar is released so isoflurane can be used, the nib in the hole will prevent the sliding bar from engaging the hole in the halothane vaporizer (because the latter has not been turned off).

**Figure 1.** Note the interlocking bar between the vaporizers, that are in series

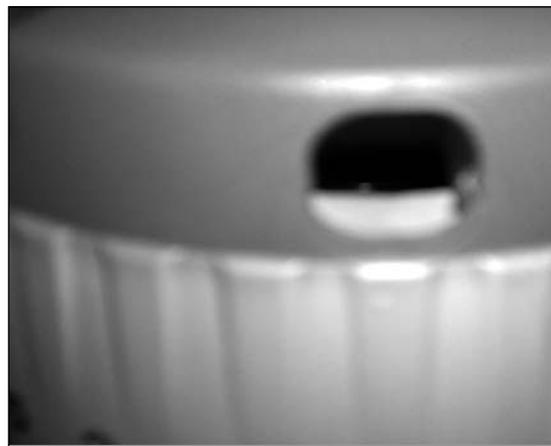
If the nib is missing, damaged or broken, then there is no nib in the hole (Figure 2) and there is nothing to prevent the sliding bar from engaging the hole in the halothane vaporizer. Thus, halothane is at 5% (not turned off), the sliding bar is engaged and the isoflurane vaporiser is also on (Figure 3), with the consequence that the patient receives a mixture of halothane and isoflurane. Unrecognized, this is capable of causing a fatal incident intra-operatively.

We discovered this during a machine check in our theatre, and propose the following mechanism for the damage to the vaporizer. The positioning of the Dräger anaesthetic machine in this particular theatre is unique in our hospital, in that it is positioned on

**Figure 2.** Halothane vaporizer with nib missing

The damaged nib has been reported to manufacturers through their representative VAMED Engineering. We report this to alert other beneficiaries of the Dräger anaesthetic machine, and remind anaesthetists of the importance of mandatorily carrying out a machine check prior to administering each anaesthetic. Ideally right-handed anaesthetists should have their machines positioned on their right, and avoid using excessive force to turn the dial.

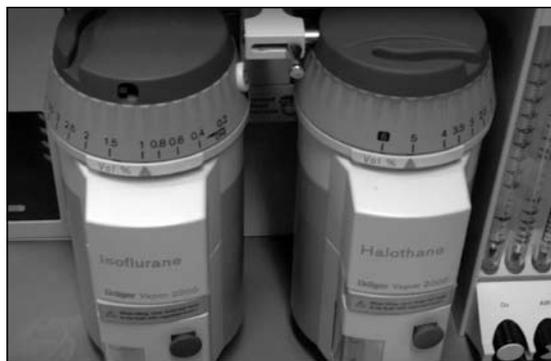
**Figure 3.** The isoflurane nib is visible and the halothane vaporizer is locked at the 5% position with isoflurane being delivered at 1%

If a thorough machine check has not been conducted, a right-handed anaesthetist may use his left hand to 'turn off' the faulty vaporizer but in an anticlockwise direction, but unknowingly, the vaporizer will be at 5%, and the sliding bar will engage at the 5% position because there is no nib. Isoflurane will be turned on, but the patient will also be receiving halothane at 5%.

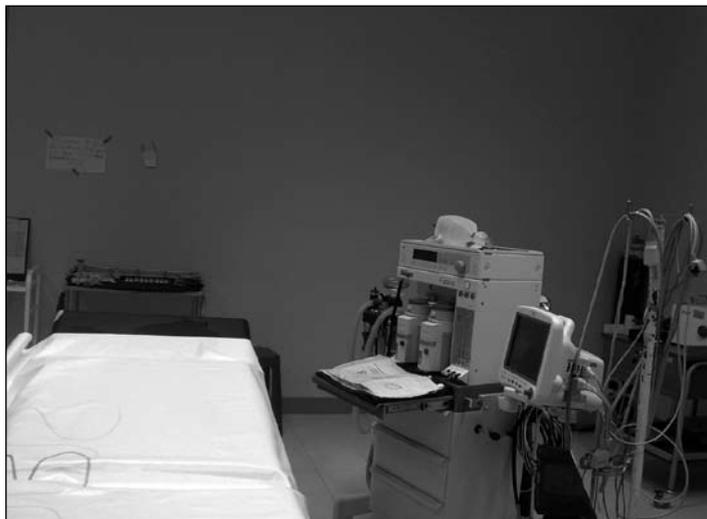
the left of the operating table (Figure 4), that is on the left of a right-handed anaesthetist. In trying to turn off the vaporizer, a right-handed anaesthetist (who is used to the machine being on his right) may have used his left hand to inadvertently turn the dial anticlockwise instead of clockwise. Excessive force may have broken the plastic nib.

**Figure 4.** Anaesthetic machine on the left of the operating table, requiring a right-handed anaesthetist to use his left hand to turn the vaporizer dial
