### Damaged Dräger vaporizer interlock pin: potential for a fatal anaesthetic incident

**Christie N Mato, Maxwell Tobin**, University of Port Harcourt Teaching Hospital, Nigeria

We wish to report the potential for a fatal intraoperative incident related to a damaged Dräger vaporizer interlocking pin.

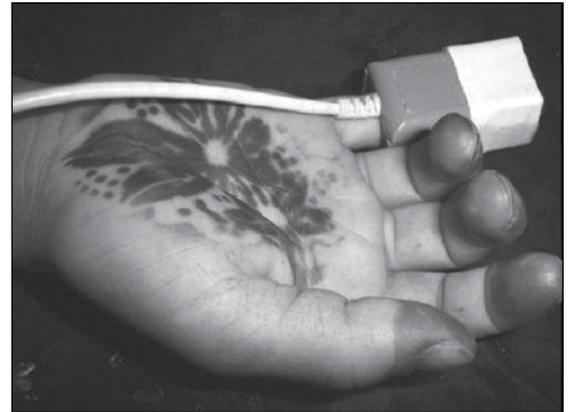
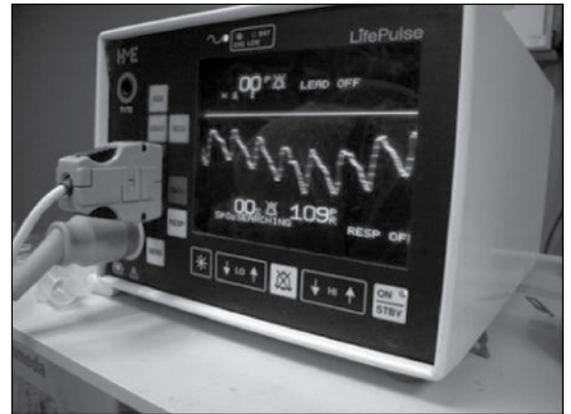
**Figure 2.** (A) Pulse oximeter applied to a patient with henna

Presence of this dye can cause interference with the pulse oximetry reading (Figure 2), which gives a good waveform, an accurate pulse rate, but an arterial oxygen saturation reading of 0. This interferes greatly with our monitoring of female patients and we report our experience for the benefit of other anaesthetists practicing in his setting.

(B) Pulse oximetry display

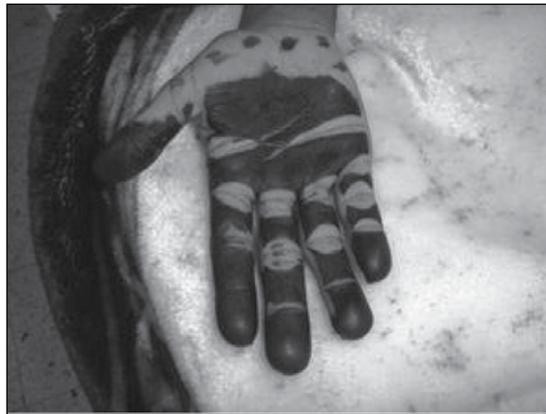
**Figure 1**

I would like to share my experience from working in the Republic of Yemen. Several factors are reported as interfering with the pulse oximetry reading. In Yemen, females use Lawsonia Inermis (henna) dye on their hands and feet as ornamental decoration. This dye cannot be removed but fades with time. An example is shown in Figure 1.
